# Manhole Inspection Summary

Manhole # S09OO1022MH

Insp Date: **5/15/07 12:22 PM**

**Location** Address: **3211 SPAULDING AVE** Cross Street: **DENMORE AVE**

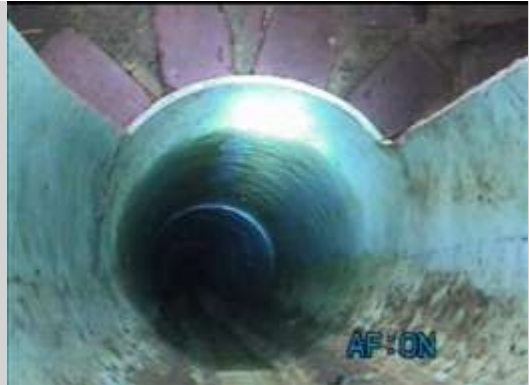
12 O'Clock Outflow

8 in. Circular Gravity Sewer  
Pipe Out @ 12 O'Clock

Pipe Material: **Clay** ☒ Pipe Lined

Deposits: ☒ None ☐ Mud ☐ Sludge ☐ Debris ☐ Grease

Infiltration: **None** Pipe Seal Cond: **Sound**

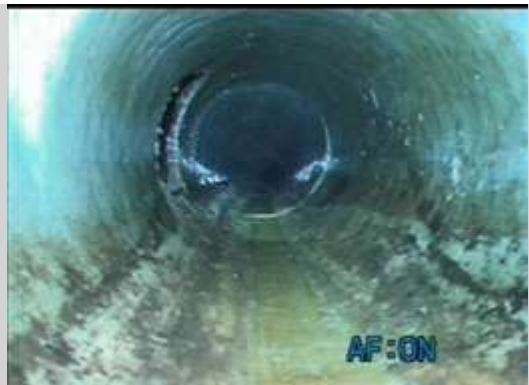
6 O'Clock Inflow

8 in. Circular Gravity Sewer  
Pipe In @ 6 O'Clock

Pipe Material: **Clay** ☒ Pipe Lined

Deposits: ☒ None ☐ Mud ☐ Sludge ☐ Debris ☐ Grease

Infiltration: **None** Pipe Seal Cond: **Sound**
